Arkema Facility - Harvey Response

Crosby, TX

September 7, 2017

Project #109489 Summary

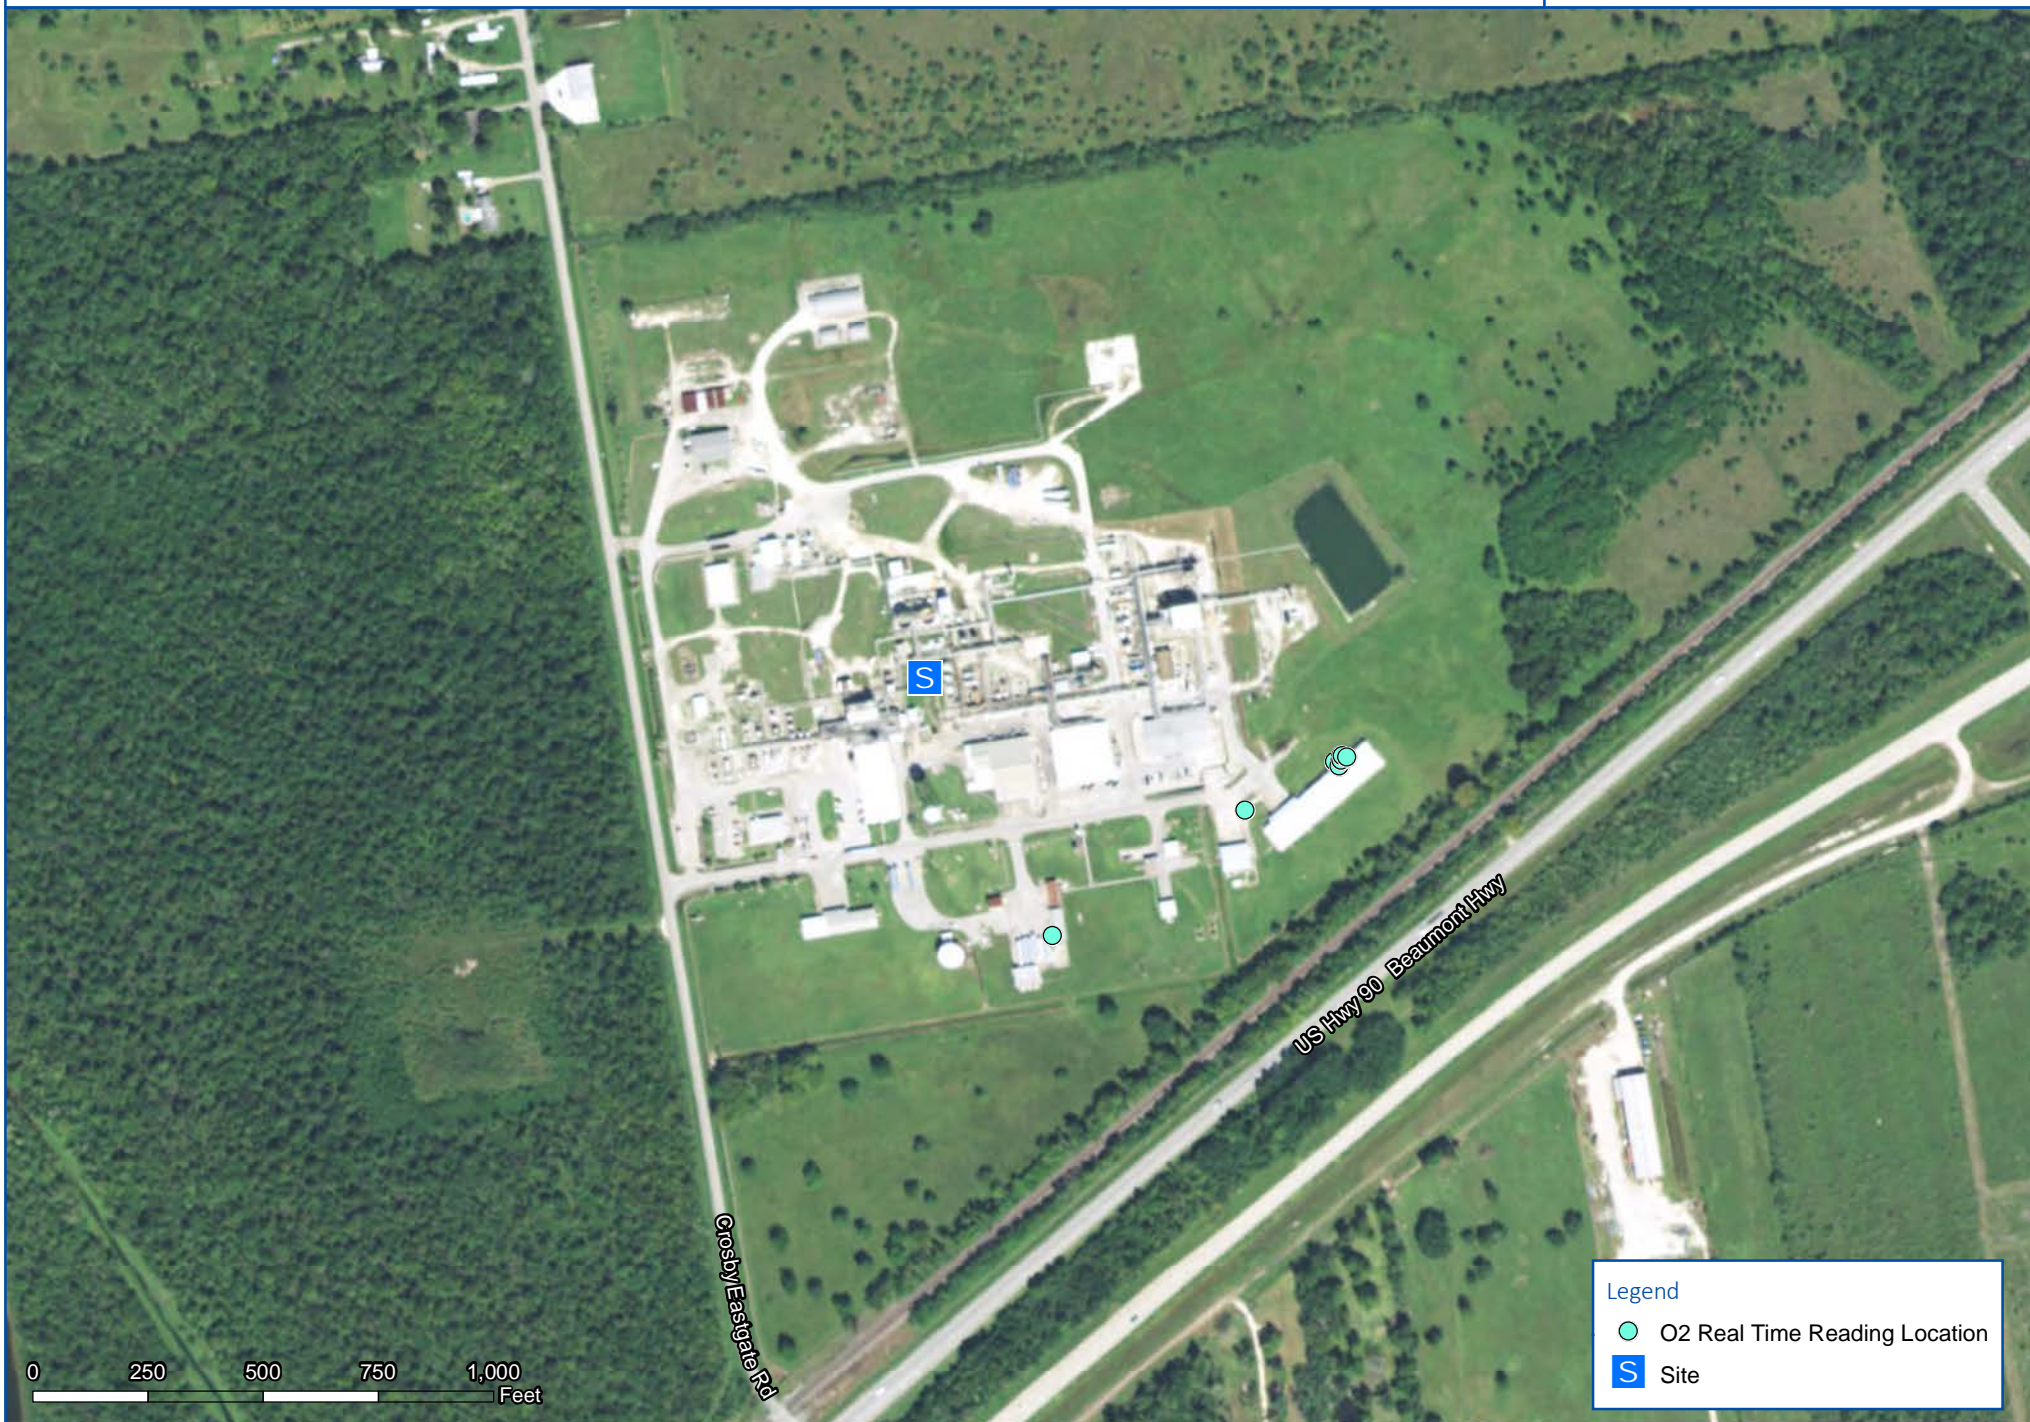
O2 Real Time Reading Location

All real-time air monitoring instrumentation was calibrated per the manufacturer's recommendations prior to air monitoring. Handheld, real-time air monitoring was conducted for oxygen (O₂) and volatile organic compounds (VOCs) using RAE Systems MultiRAE instruments. Additionally, particulate matter (PM_{2.5}) was assessed using TSI SidePak AM510s. **Table 1** summarizes the data for all real-time air monitoring readings recorded in the Crosby, TX Community from 06:00 on September 6, 2017 through 06:00 on September 7, 2017 and Table 2 summarizes the Worker Activity real-time air monitoring readings from within the site boundary for the same period. Maps of real-time air monitoring locations are provided as **Attachment B**.

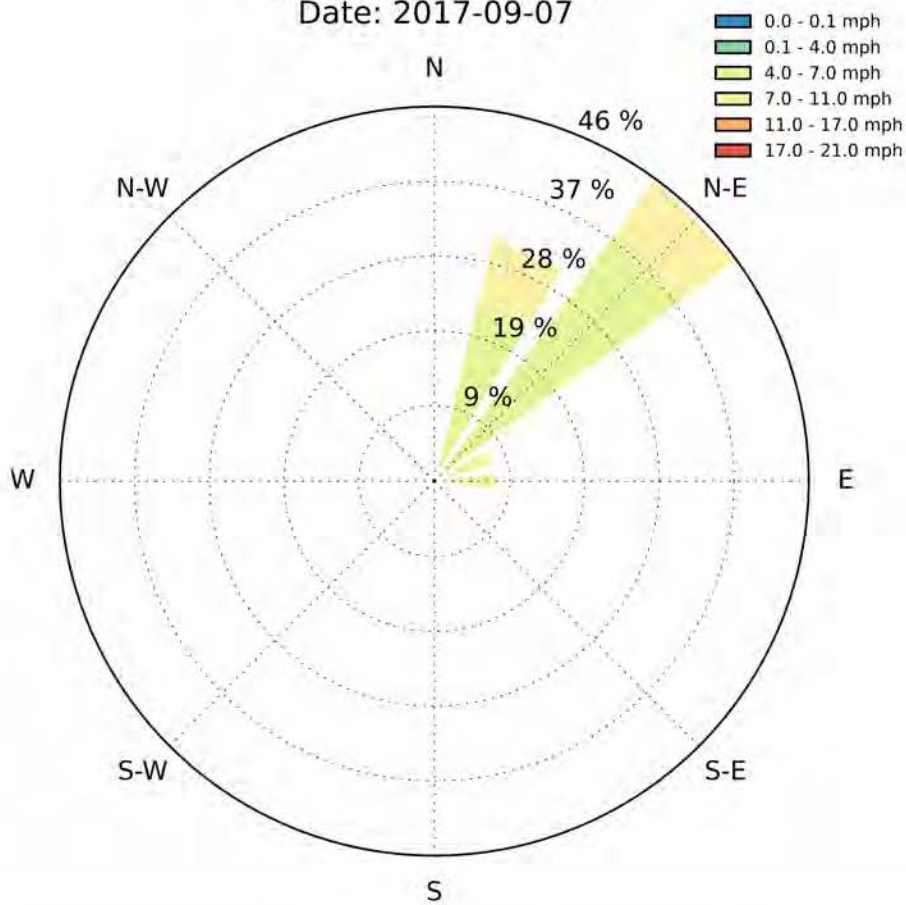
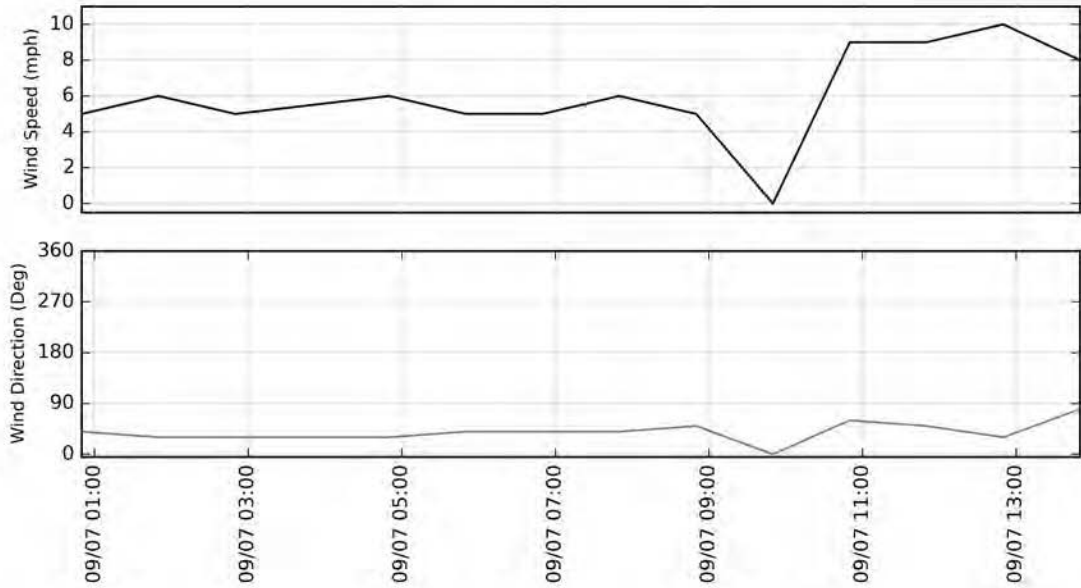
Weather Station: KHPY
Date: 2017-09-07
